MA 39 - VFA 2018-1065.02

Test Report

Limestone Slabs

Test programme: In compliance with ÖNORM EN 1339, version of 1 January 2007,

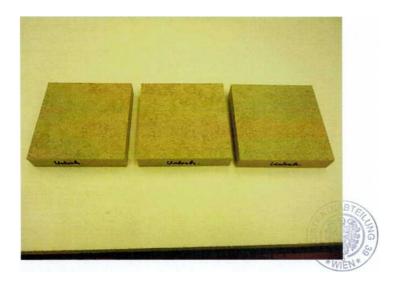
Image no. 2018-1065-01-1

Slabs labelled "untreated" (untreated slabs)

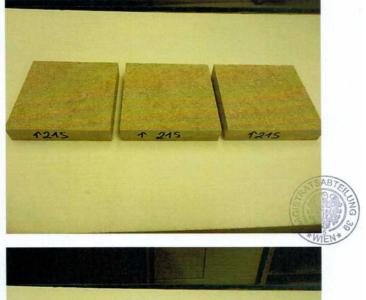
Image no. 2018-1065-01-2

Slabs labelled "21S" (upper side impregnated with "21S")

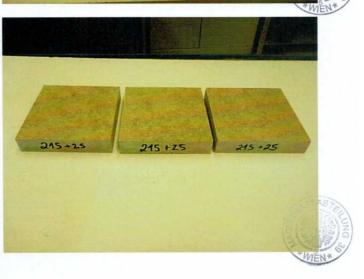
Image no. 2018-1065-01-3

Slabs labelled "21S +25" (upper side impregnated with "21S + 25")

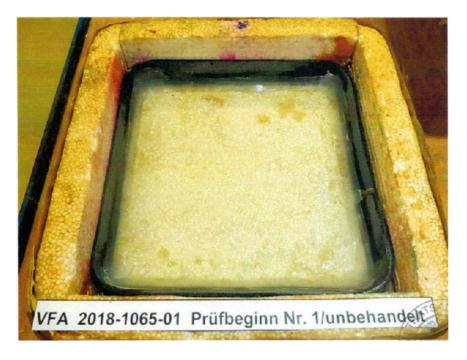
Image no. 2018-1065-01-5

Slab no. 1, start of test (untreated)

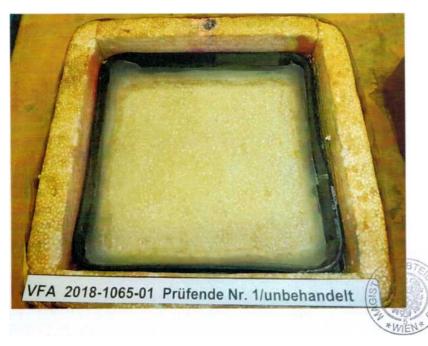
Image no. 2018-1065-01-6

Slab no. 1, end of test (untreated)

Weathering amount: 2 g/m²

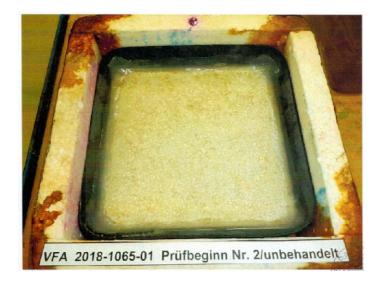
Image no. 2018-1065-01-7

Slab no. 2, start of test (untreated)

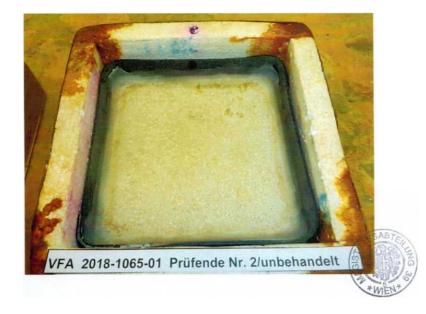
Image no. 2018-1065-01-8

Slab no. 2, end of test (untreated)

Weathering amount: 16 g/m

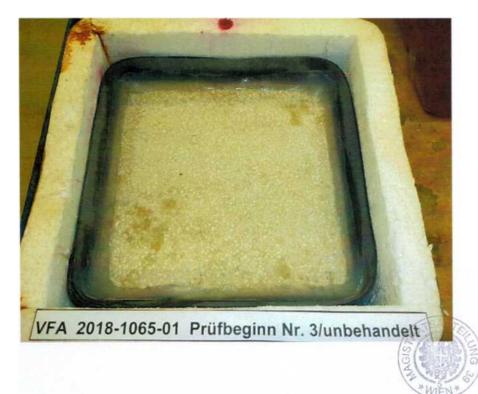
Image no. 2018-1065-01-9

Slab no. 3, start of test (untreated)

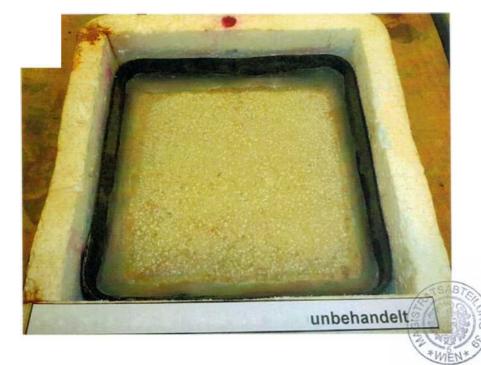
Image no. 2018-1065-01-10

Slab no. 3, end of test (untreated)

Weathering amount: 1 g/m²

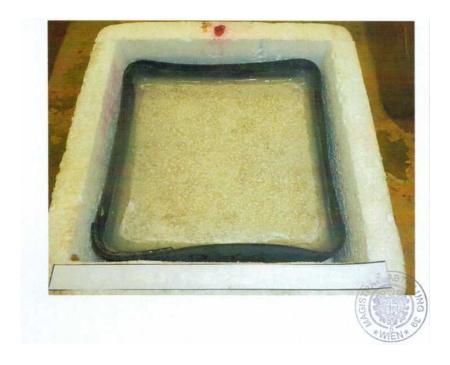
Image no. 2018-1065-01-11

Slab no. 1, start of test (upper side impregnated with "21S")

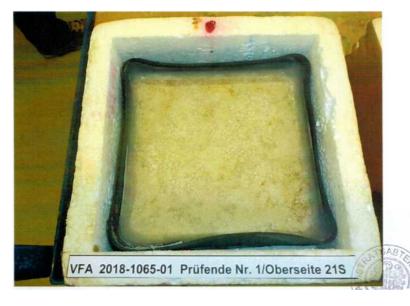
Image no. 2018-1065-01-12

Slab no. 1, end of test (upper side impregnated with "21S")

Weathering amount: 5 g/m²

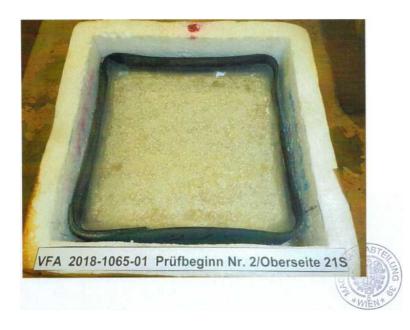
Image no. 2018-1065-01-13

Slab no. 2, start of test (upper side impregnated with "21S")

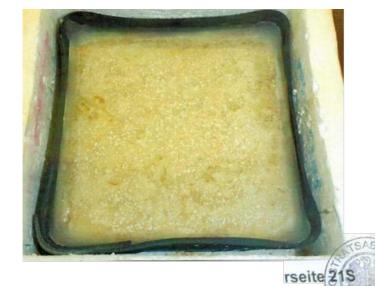
Image no. 2018-1065-01-14

Slab no. 2, end of test (upper side impregnated with "21S")

Weathering amount: 8 g/m

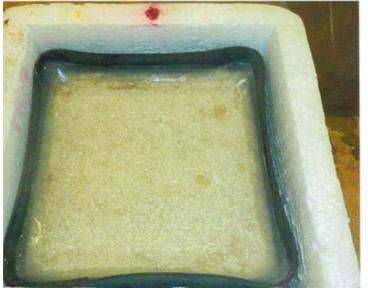
Image no. 2018-1065-01-15

Slab no. 3, start of test (upper side impregnated with "215")

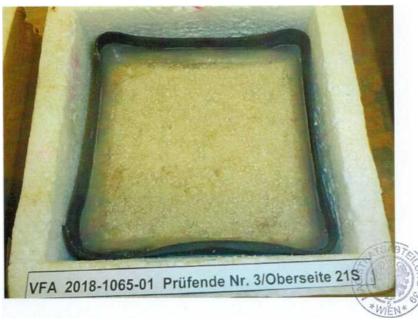
Image no. 2018-1065-01-16

Slab no. 3, end of test (upper side impregnated with "21S")

Weathering amount: 2 g/m²

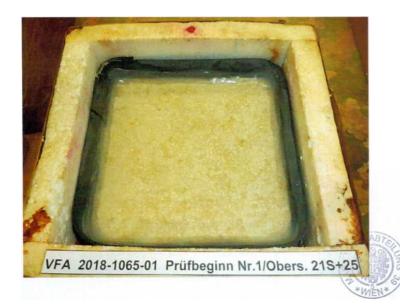
Image no. 2018-1065-01-17

Slab no. 1, start of test (upper side impregnated with "21S +25")

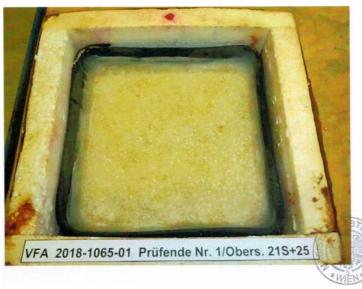
Image no. 2018-1065-01-18

Slab no. 1, end of test (upper side impregnated with "21S +25")

Weathering amount: 1 g/m²

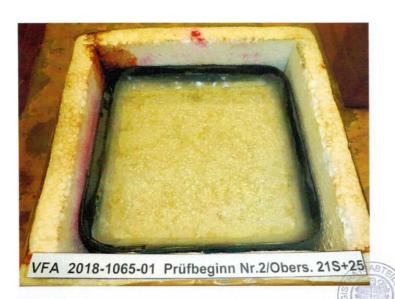
Image no. 2018-1065-01-19

Slab no. 2, start of test (upper side impregnated with "21S +25")

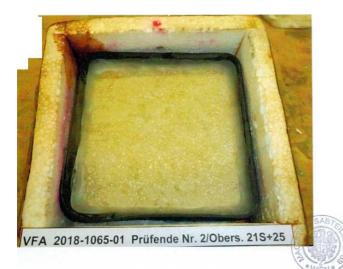
Image no. 2018-1065-01-20

Slab no. 2, end of test (upper side impregnated with "21S +25")

Weathering amount: 1 g/m

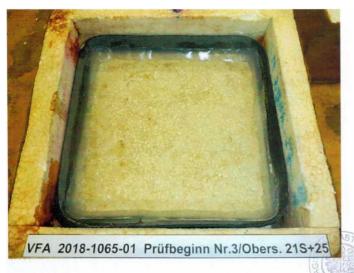
Image no. 2018-1065-01-21

Slab no. 3, start of test (upper side impregnated with "21S +25")

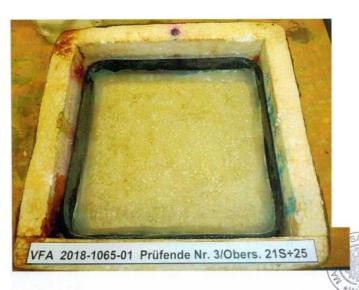
Image no. 2018-1065-01-22

Slab no. 3, end of test (upper side impregnated with "21S +25")

Weathering amount: 1 g/m²
